California Levee Vegetation Research Program

Influence of Tree Roots and Mammal Burrowing Activity on Levee Integrity:

Volume 4. – Field Evaluation of Burrowing Animal Impacts and Effectiveness of Remedial Measures

Geotechnical Engineering
University of California, Berkeley
Report UCB GT 13-03 vol. 4

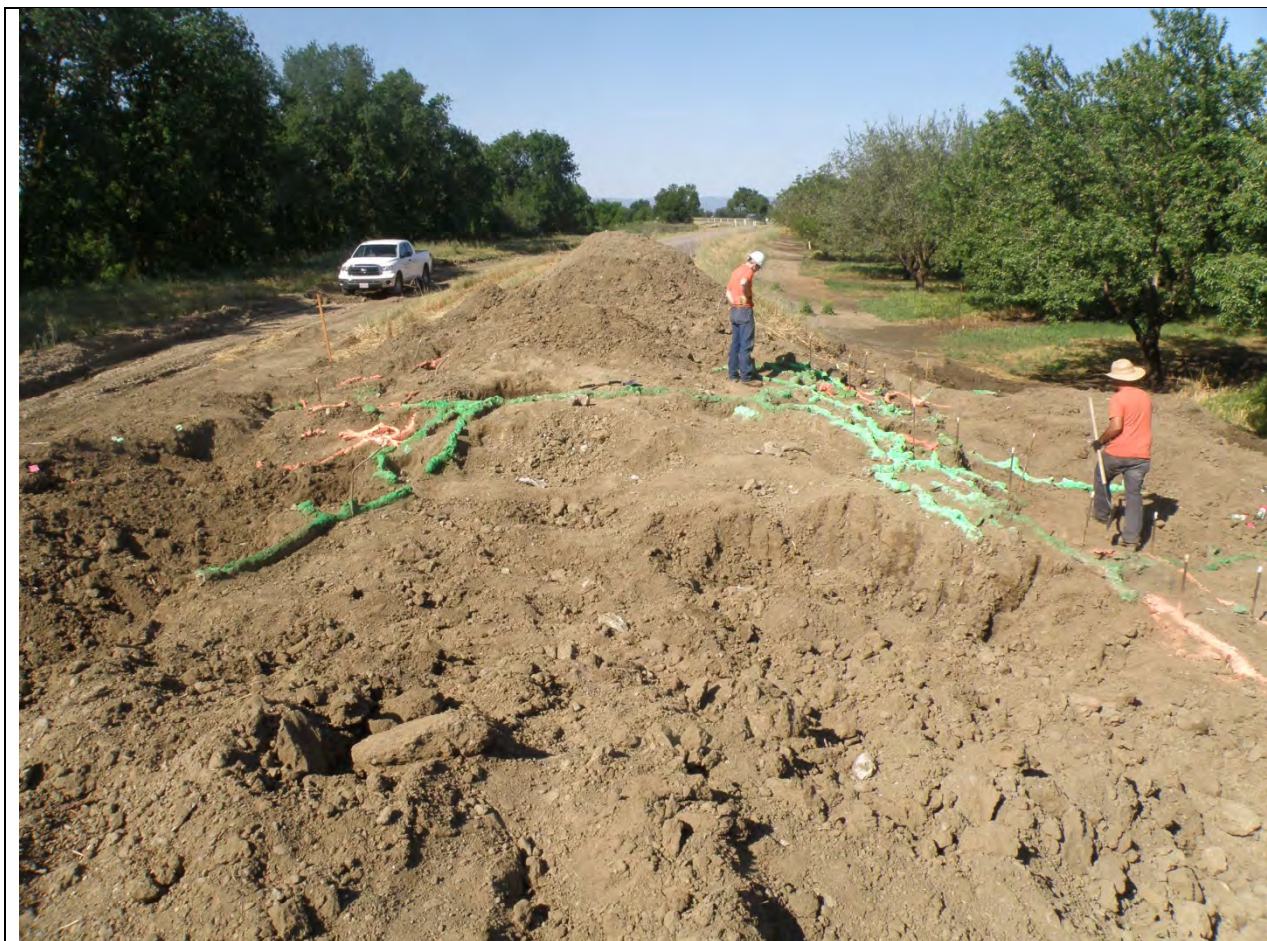
Photo 4A -30. View of gopher and ground squirrel burrow system on the Clayey Site. Landside slope to the right of the image.
